**Flood Control Project Maintenance
Levee Inspections**

Maintenance Issue Types Only, Levee Inspection Report By Mile - Fall 2019

Sacramento Maintenance Yard Willow Slough Bypass

Waterway	Bank	Unit Miles	Inspection Start/End	Inspector
Unit No. 01 Willow Slough Bypass or North Levee	Left	5.05	10/16/2019 10/16/2019	Zach Jojola

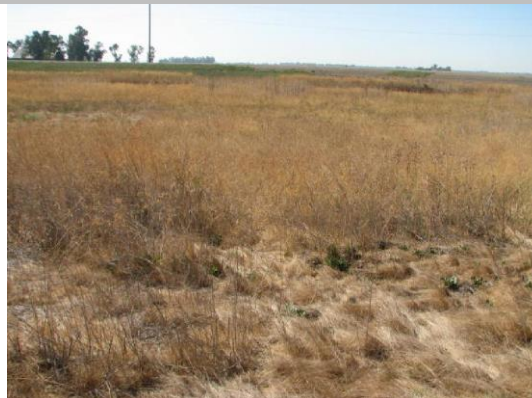
Photo 3 of 3 : UCIP_FA_2019_44907_22892.jpg

Comment Code						
Inspector Comment						
DS_ID:17608 FS_ID:44907 EP_NO: 10313 Repair Type: No Action Needed Crossing Status: Found UCIP Comments: 04/12/2017 LS - dump has it plugged, WS - ditch need to be established debris higher than water, inspected by JK, RF. (DWR Sacramento Yard - C. Lund) 09/19/2012 Pipe sits on concrete saddle on WS. (DWR UCIP - P. Amatya) FIELD_STRUCT_DESC: 24-inch corrugated metal drainage pipe through the levee, 13.5 feet below the crown. Flap gate is located on the waterside (WS) end. (24-inch pipe [HLM 0.79] authorized under Automatic Board Order (ABO) issued as Permit No. 10313, 1974 - Lear). [Additional Reference(s): DWR Levee Log, 1990. USACE Sacramento O&M Manual Unit 120, Willow Slough Channel Relocation and Levee Construction, February 1947, Drawing No. 50-4-2281 Sheet 2, 4 (Station 232+43)] FS Date: 5/5/2015 8:06:14 AM

Waterside view

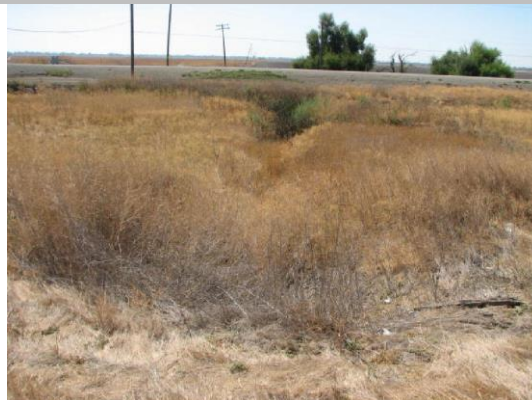
Photo 3 of 3 : UCIP_FA_2019_44929_22931.jpg

Comment Code						
Inspector Comment						
DS_ID:17623 FS_ID:44929 EP_NO: 10310 Repair Type: No Action Needed Crossing Status: Found UCIP Comments: FIELD_STRUCT_DESC: 20-inch steel drainage pipe sleeved though 30-inch corrugated metal pipe through the levee, 12.5 feet below the crown. 24-inch flap gate is located on the waterside (WS) end. (30-inch pipe [HLM 1.53] authorized under Automatic Board Order (ABO) issued as Permit No. 10310, 1974 - Hunt-Wesson Foods, Inc.) [Additional Reference(s): DWR Levee Log, 1990. USACE Sacramento O&M Manual Unit 120, Willow Slough Channel Relocation and Levee Construction, February 1947, Drawing No. 50-4-2281 Sheet 2 (Station 192+88)] FS Date: 5/5/2015 8:20:02 AM

Waterside overview

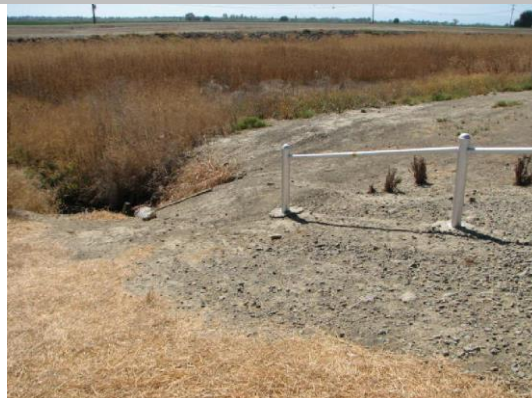
Photo 1 of 3 : UCIP_FA_2019_44947_22984.jpg

Comment Code						
Inspector Comment						
DS_ID:17622						
FS_ID:44947						
EP_NO: 10316						
Repair Type: No Action Needed						
Crossing Status: Found						
UCIP Comments: 04/12/2017 good/clear on LS & WS, inspected by JK, RF. (DWR Sacramento Yard - C. Lund)						
05/28/2013 Debris on waterside flap gate has been removed. (DWR Sacramento Yard - C. Lund)						
09/19/2012 Debris on waterside flap gate. Needs debris removal from the pipe. (DWR UCIP - P. Amatya)						
FIELD_STRUCT_DESC: 24-inch corrugated metal drainage pipe through the levee, 11 feet below the crown. Flap gate is located on the waterside (WS) end. Concrete pad is located on the WS. (24-inch pipe [HLM 3.57] authorized under Automatic Board Order (ABO) issued as Permit No. 10316, 1974 - Stafford). [Additional Reference(s): DWR Levee Log, 1990. USACE Sacramento O&M Manual Unit 120, Willow Slough Channel Relocation and Levee Construction, February 1947, Drawing No. 50-4-2281 Sheet 1 (Station 85+00)]

Waterside view- overview

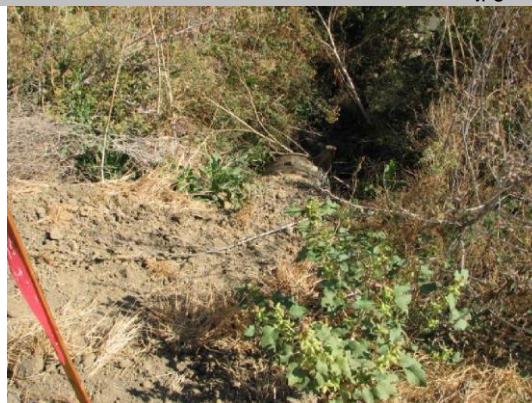
Photo 2 of 3 : UCIP_FA_2019_45286_22460.jpg

Comment Code					
Inspector Comment					
DS_ID:534 FS_ID:45286 EP_NO: 10327 Repair Type: No Action Needed Crossing Status: Found UCIP Comments: 04/12/2017 WS & LS - good/clear, inspected by JK, RF. (DWR Sacramento Yard - C. Lund) 05/24/2013 Flap gate repaired. (DWR Sacramento Yard - C. Lund) 09/20/2012 Flap gate is not properly closing. (DWR UCIP - P. Amatya) FIELD_STRUCT_DESC: 24-inch corrugated drainage pipe through the levee, 17.5 feet below the crown. Flap gate is located on the waterside (WS) slope. (24-inch pipe [HLM 0.78] authorized under Automatic Board Order (ABO) issued as Permit No. 10327 - Heidrick). [Additional Reference(s): DWR Levee Log, 1990. USACE Sacramento O&M Manual Unit 120, Willow Slough Channel Relocation and Levee Construction, February 1947, Drawing No. 50-4-2281 Sheet 1 (Station 47+00)] FS Date: 5/14/2015 1:36:52 PM

Waterside view- overview

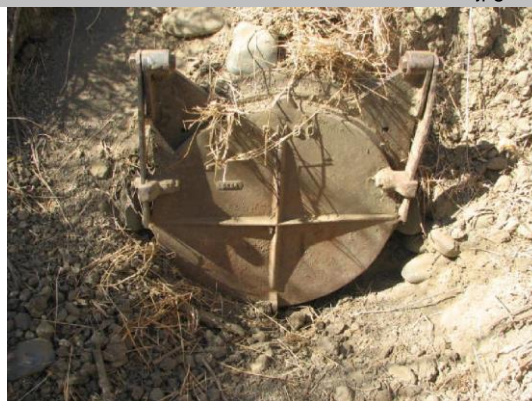
Photo 1 of 3 : UCIP_FA_2019_13725_22470.jpg

Comment Code					
Inspector Comment					
DS_ID:536 FS_ID:13725 EP_NO: 10331 Repair Type: No Action Needed Crossing Status: Found UCIP Comments: 04/12/2017 WS & LS - good/clear, inspected by JK, RF. (DWR Sacramento Yard - C. Lund) 09/20/2012 Landside- upper corner of headwall was chipped off. (DWR UCIP - P. Amatya) FIELD_STRUCT_DESC: 24-inch corrugated metal drainage pipe through the levee, 13.5 feet below the crown. Flap gate is located on the waterside (WS) end. (24-inch pipe [HLM 1.15] authorized under Automatic Board Order (ABO) issued as Permit No. 10331, 1974 - Lavezzo). [Additional Reference(s): DWR Levee Log, 1990. USACE Sacramento O&M Manual Unit 120, Willow Slough Channel Relocation and Levee Construction, February 1947, Drawing No. 50-4-2281 Sheet 1 (Station 66+98)] FS Date: 5/24/2013 8:22:08 AM

Waterside view- flap gate and CM pipe

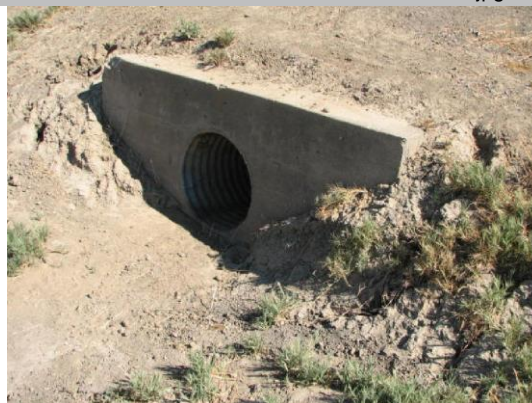
Photo 2 of 3 : UCIP_FA_2019_13725_22469.jpg

Landside view- concrete headwall and pipe

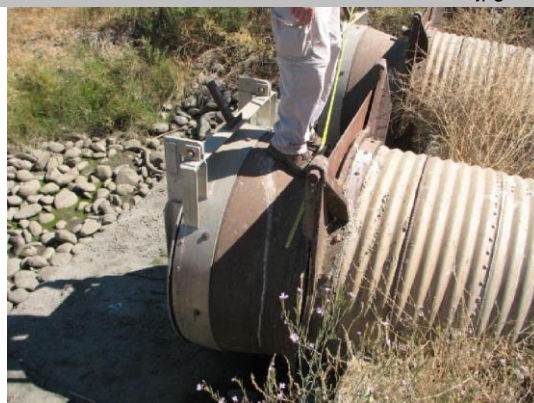
Photo 3 of 3 : UCIP_FA_2019_45294_22792.jpg

Comment Code						
Inspector Comment						
DS_ID:541 FS_ID:45294 EP_NO: 10335 Repair Type: No Action Needed Crossing Status: Found UCIP Comments: 09/20/2012 Landside view photos are missing. Daylight pipe is a steel pipe. The pipe through the levee may be a CMP. (DWR UCIP - P. Amatya) FIELD_STRUCT_DESC: 1 of 2. 42-inch corrugated metal drainage pipe through the levee, 12 feet below the crown. Flap gate located on the waterside (WS) end. 42-inch pipe sleeved through a 48-inch corrugated metal pipe (CMP). (two 48-inch pipes [HLM 3.54] authorized under Automatic Board Order (ABO) issued as Permit No. 10335, 1974 - Snyder). [Additional Reference(s): DWR Levee Log, 1990. USACE Sacramento O&M Manual Unit 120, Willow Slough Channel Relocation and Levee Construction, February 1947, (Station 192+80)] FS Date: 5/14/2015 1:41:55 PM

Waterside view- 42-inch steel pipe and flap gate.

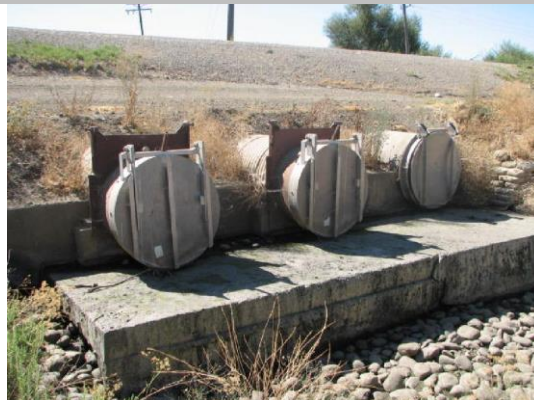
Photo 3 of 3 : UCIP_FA_2019_45295_22796.jpg

Comment Code						
Inspector Comment						
DS_ID:17729 FS_ID:45295 EP_NO: 10335 Repair Type: No Action Needed Crossing Status: Found UCIP Comments: 05/05/2017 48-inch pipe authorized under ABO/Permit No. 10335. Reference has been verified and this crossing is referenced correctly. No records were found to support the additional of the 42-inch through the 48-inch pipe. (DWR UCIP - O. Magana) 09/20/2012 Daylight pipe looks like steel pipe. The pipe through the levee may be a CMP. Needs a landside view photos which is missing. This pipe may be a 42-inch pipe mentioned in ABO 10333. (DWR UCIP - P. Amatya) FIELD_STRUCT_DESC: 2 of 2. 42-inch corrugated metal drainage pipe through the levee, 12 feet below the crown. Flap gate located on the waterside (WS) end. 42-inch pipe sleeved through a 48-inch corrugated metal pipe (CMP). (two 48-inch pipes [HLM 3.54] authorized under Automatic Board Order (ABO) issued as Permit No. 10335, 1974 - Snyder). [Additional Reference(s): DWR Levee Log, 1990. USACE Sacramento O&M Manual Unit 120, Willow Slough Channel Relocation and Levee Construction, February 1947, (Station 192+88)] FS Date: 5/14/2015 1:42:08 PM

Waterside overview- outlet structure.

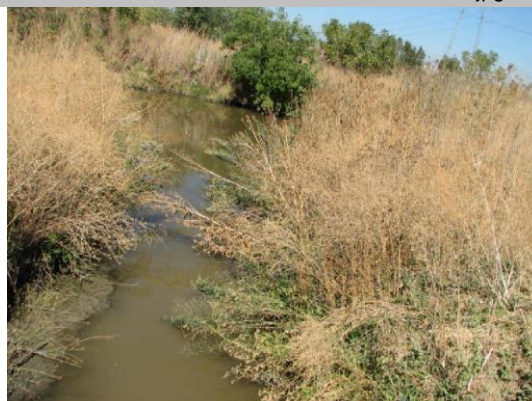
Photo 3 of 3 : UCIP_FA_2019_45302_22847.jpg

Comment Code						
Inspector Comment						
DS_ID:549 FS_ID:45302 EP_NO: 10322 Repair Type: No Action Needed Crossing Status: Found UCIP Comments: 04/12/2017 WS - submerged in water, inspected by JK, RF. (DWR Sacramento Yard - C. Lund) FIELD_STRUCT_DESC: 24-inch corrugated metal drainage pipe through the levee, 17.5 feet below the crown. Flap gate is located on the waterside (WS) end. Concrete headwall with wing walls is located on WS. (24-inch pipe [HLM 5.32] authorized under Automatic Board Order (ABO) issued as Permit No. 10322, 1974 - Chew). [Additional Reference(s): DWR Levee Log, 1990. USACE Sacramento O&M Manual Unit 120, Willow Slough Channel Relocation and Levee Construction, February 1947, Drawing No. 50-4-2281 Sheet 4 (Station 287+19)] FS Date: 5/14/2015 1:44:30 PM

Waterside view- overview

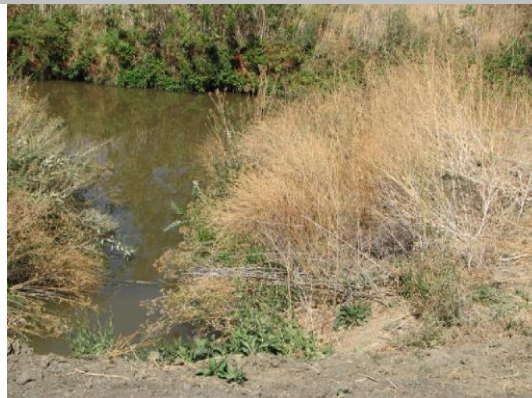
Photo 3 of 3 : UCIP_FA_2019_45305_22859.jpg

Comment Code						
Inspector Comment						
DS_ID:551 FS_ID:45305 EP_NO: 10325 Repair Type: No Action Needed Crossing Status: Found UCIP Comments: 04/12/2017 WS & LS - submerged in water, inspected by JK, RF. (DWR Sacramento Yard - C. Lund) 09/20/2012 Slide gate on landside of the levee over the field. (DWR UCIP - P. Amatya) FIELD_STRUCT_DESC: 24-inch corrugated metal drainage pipe through the levee, 18 feet below the crown. Flap gate is located on the waterside (WS) end. (24-inch pipe [HLM 5.50] authorized under Automatic Board Order (ABO) issued as Permit No. 10325, 1974 - Ferris). [Additional Reference(s): DWR Levee Log, 1990. USACE Sacramento O&M Manual Unit 120, Willow Slough Channel Relocation and Levee Construction, February 1947, Drawing No. 50-4-2281 Sheet 4 (Station 296+34)] FS Date: 5/14/2015 1:45:21 PM

Waterside view- overview.

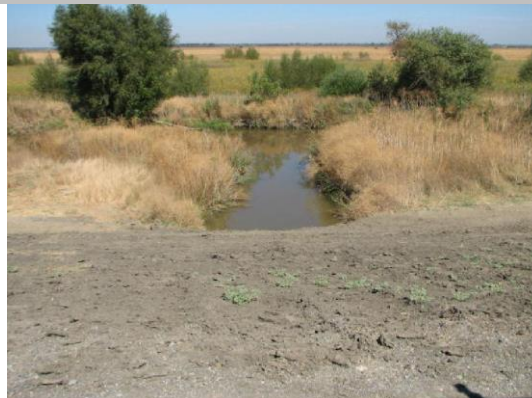
Photo 1 of 3 : UCIP_FA_2019_45307_22869.jpg

Comment Code					
Inspector Comment					
DS_ID:553					
FS_ID:45307					
EP_NO: 10325					
Repair Type: No Action Needed					
Crossing Status: Found					
UCIP Comments: 04/12/2017 WS - submerged in water, inspected by JK, RF. (DWR Sacramento Yard - C. Lund)					
09/20/2012 Outlet structure under water in waterside of the levee. No access to the inlet structure. (DWR UCIP - P. Amatya)					
FIELD_STRUCT_DESC: 24-inch corrugated metal drainage pipe through the levee, 18 feet below the crown. Flap gate is located on the waterside (WS) end. (24-inch pipe [HLM 5.98] authorized under Automatic Board Order (ABO) issued as Permit No. 10325, 1974 - Ferris) [Additional Reference(s): DWR Levee Log, 1990. USACE Sacramento O&M Manual Unit 120, Willow Slough Channel Relocation and Levee Construction, February 1947, Drawing No. 50-4-2281 Sheet 4 (Station 328+51)]					
FS Date: 5/14/2015 1:45:44 PM

Waterside view- overview
